## AN ASSESSMENT OF PHOTOVOLTAIC POWER IN THE TELSTRA NETWORK

#### Ian J. Muirhead and Barry K. Hawkins

Telstra Research Laboratories P.O. Box 249, Rosebank MDC Clayton, Victoria, 3168 Email: I.Muirhead@TRL.Telstra.com.au B.Hawkins@TRL.Telstra.com.au

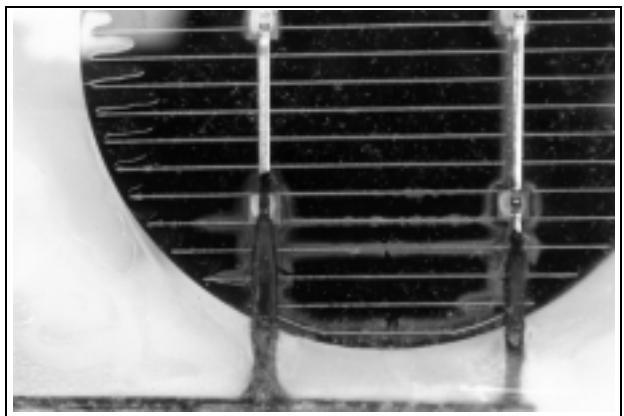
Figure 1. Corrosion of cell interconnects from moisture entering around the terminal box.

A common method of mounting modules on a rack was to have the upper module of a vertical pair inverted, such that the terminal boxes were adjacent. This configuration made the wiring between modules easier. However, such mounting was observed to increase the probability of corrosion in the inverted module, particularly in modules which had inadequate sealing around the point where the wires entered the laminate, under the terminal box. An example of the corrosion found in the most susceptible module is shown in Figure 1.

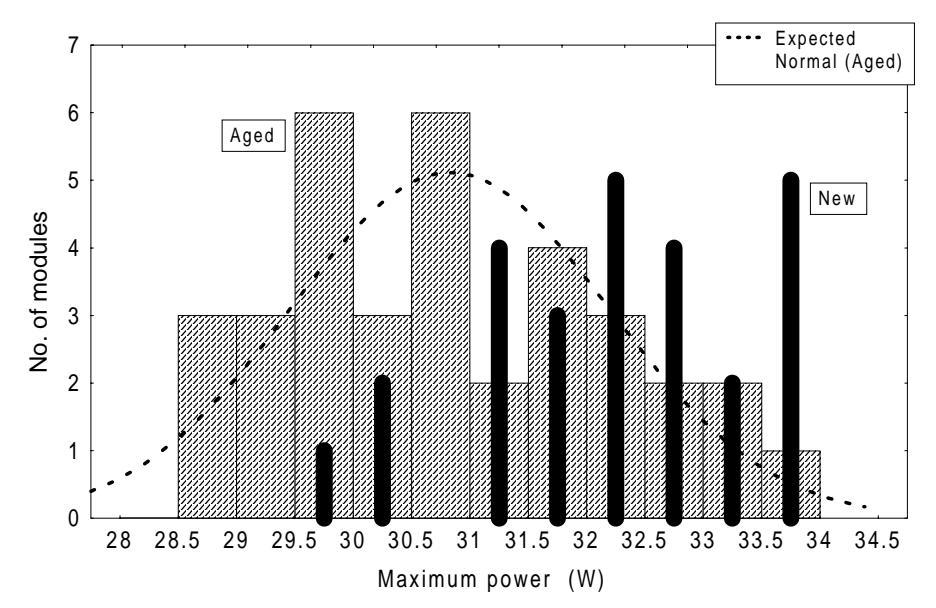
It is evident from these data that the electrical performance of this type of module did not significantly deteriorated during the  $8\frac{1}{2}$  years of exposure in the Melbourne climate. Statistically the  $P_{max}$  of only the "aged" module distribution was normally distributed<sup>4</sup>. The values measured for module I<sub>sc</sub> were normally distributed for the large 60 module sample and before and after exposure of the 35 modules.

Figure 2 The distribution of  $P_{max}$  of commercial early 1980's vintage modules both when new (solid bars) and after 8<sup>1</sup>/<sub>2</sub> years of exposure in the Melbourne climate (hatched bars).

There was no obvious trend visible between  $P_{max}$  and date of manufacture. The mean degradation rate is small; approximately 0.4% per annum for  $P_{max}$  and 0.1% per annum for  $I_{sc.}$  The modules also appear in very good physical condition. These observations are consistent with the data obtained from visiting Telstra installations in the Northern Territory.

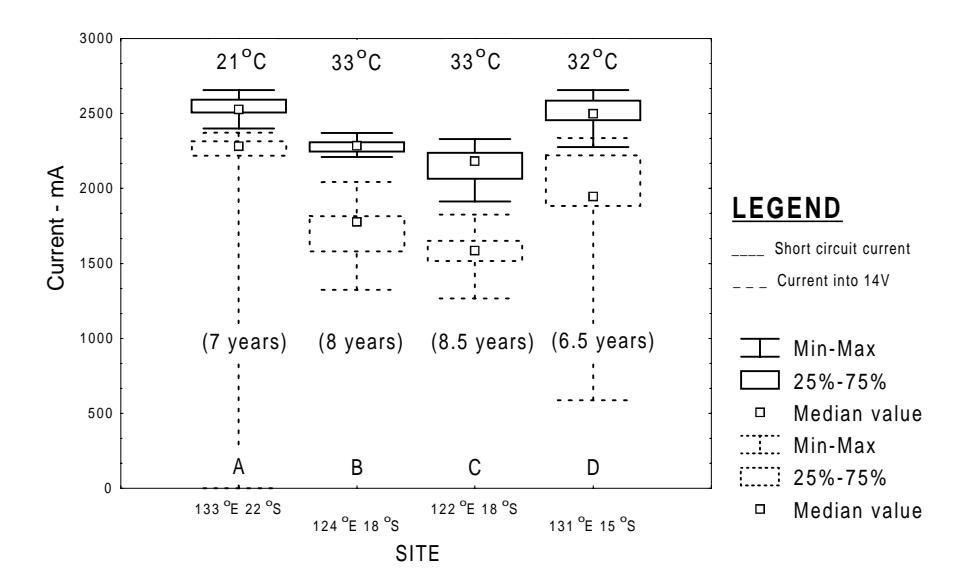
Figure 3 The distribution of  $I_{sc}$  and  $I_{14V}$  measured for a total of 76 modules at 4 Telstra sites. The whiskers represent the range of values recorded at each site; the box encloses data between the 25% and 75% quartiles; the point locates the median value. Air temperature at the time of measurement is shown at the top.

Although the modules at site A are slightly older than those at site D, the mean value of  $I_{sc}$  is 2% higher<sup>5</sup>. A statistical comparison of the two sample populations indicates that there is a greater than 95% probability that the modules have aged at a different rate. This reinforces the general observation that the climatic environment in which the modules are exposed will affect the rate of ageing. Similarly as expected, from the data it is evident that the longer the modules have been exposed outdoors, the greater the loss in  $I_{sc}$ . Based on these data the lifetime of the modules (to 80% of rated  $I_{sc}$ ) is approximately 15 years, although there is a relatively large estimated uncertainty of  $\pm$  3 years.

The currents measured for each module into the 14V load are interesting<sup>6</sup>. Because  $I_{14V}$  is a function of more parameters than  $I_{sc}$ , each of which will add to the scatter, it was expected that the variation in  $I_{14V}$  within samples would be larger than that of  $I_{sc}$ , and this was observed. However, while the behaviour of one module at site A, providing normal  $I_{sc}$  but zero current into 14V can be explained, the reason behind the low value of  $I_{14V}$  for one module at site D cannot positively be identified based on the simple field measurements.

The  $I_{14V} = 0$  datum at site A is symptomatic of by-pass diode failure. This module employed two by-pass diodes protecting each of the two (nominal) 6V strings. A diode normally fails in a short circuit condition (Thornton). In such a state the module will still provide a normal value for  $I_{sc}$  (voltage independent) but because  $V_{oc}$  has been reduced by half, to between 9 and 10 volts, there is not sufficient potential to drive the 14V load. Hence zero current. In a 12V system failure of one of the two by-pass diodes will make the module inoperable; in a 48V system typically used by Telstra the effect will be similar to severe performance
